Transportation Study

1.0 Introduction and Background

The City of Cedartown (the City) contracted with JIG in November 2001 to conduct a transportation study of downtown Cedartown. The purpose of the study is to address safety and operational issues associated with 18 key intersections locations identified by the City. **Figure 1.1** depicts the study area location, which is an approximate area encompassing the eighteen (18) study intersections. **Table 1.1** presents a list of the 18 study area intersections.

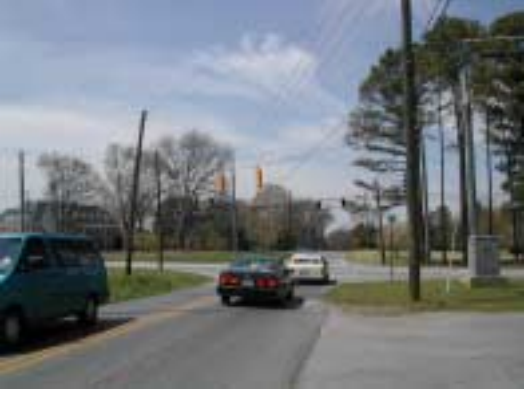
Intersection	Observation 1	Observation 2
<p>John Hand Road and Main Street <i>(Signalized intersection)</i></p>	  <p>No protected (left-turn) phase signalization</p>

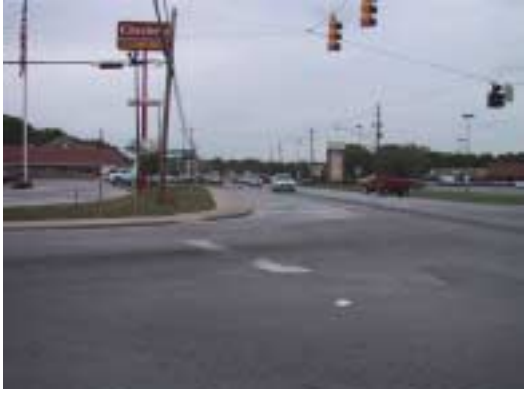
<p>No crosswalks or sidewalks</p>
<p>Jule Peek Avenue and Main Street <i>(Signalized intersection)</i></p>

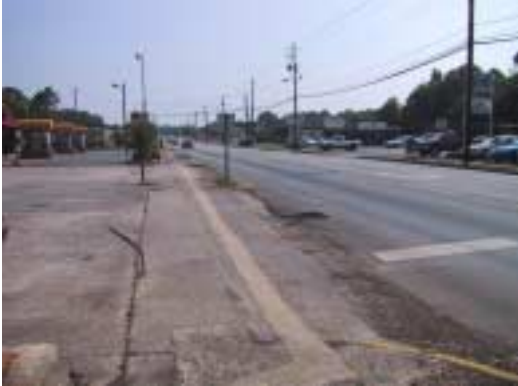
<p>Excessive driveways near intersection and deficient sidewalks</p>

Girard Avenue and Main Street <i>(Signalized intersection)</i>	Excessive curb cuts for vacant lot.	1) Upon redevelopment of the property on the south western corner, require developer to close one of the two existing driveways on Main Street, and making the other driveway a "right-in, right-out" only (primary exit driveway would be on Girard Avenue).	Responsibility of the next developer	N/A
	Poor sidewalks on south west corner of intersection.	Replace sidewalks	\$7,500	2
	No Crosswalks/Pedestrian Signalization	Add crosswalks and ped signals	\$6,500	2
Queen Street and Main Street <i>(Signalized intersection)</i>	Evaluate modifications to correct intersection geometry	Upon review of existing geometry, it appears the intersection operates sufficiently and without major accidents as is. Signalization should be further evaluated by GDOT as part of their signal replacement and retiming project).	N/A	N/A

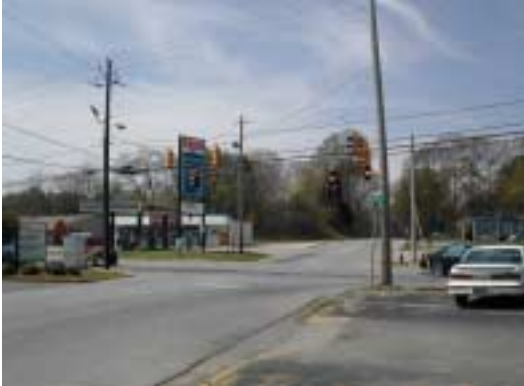
<p>Fading street markings, and no crosswalks</p>
<p>Queen Street/Philpot Street/Main Street <i>(Signalized intersection)</i></p>

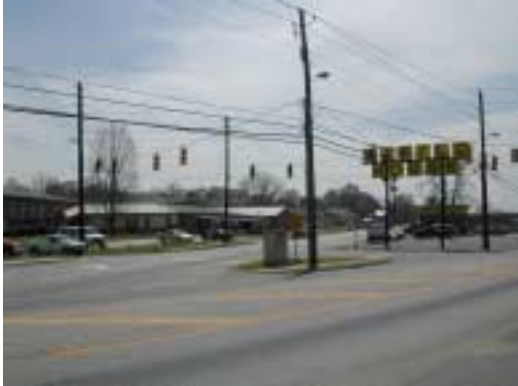
<p>Intersection island utility box blocks sight distance and is aesthetically deficient</p>

Intersection	Observed Deficiencies	Recommended Improvement	Estimated Cost	Priority Rank
	Center Island not aesthetically pleasing	Move signal operation box and re-landscape island	\$20,000	3
East Avenue and Main Street <i>(Signalized intersection)</i>	Left-turn signalization at this intersection does not appear to be warranted based upon review of available data.	GDOT needs to assess timing for left-turn protective phases, and possibility of eliminating phase if not required.	\$3,000	2
	Through movement along East Ave not straight (lane shifts). This is confusing and dangerous to unfamiliar drivers	<ol style="list-style-type: none"> 1) Remove grass mound protruding into traffic lane on southwest corner of intersection. 2) Restripe all lanes on East Ave, west of Main Street to produce two 12-foot lanes on eastbound East Ave (shift of four feet to the south). This will lessen the dramatic lane shift that currently exists along East Ave through Main Street. 3) Re-stripe with "chicken track" lines within center of intersection (dotted lines) to better mark remaining lane shift 	\$5,000	1

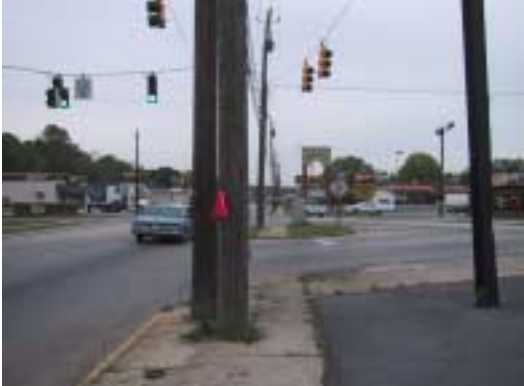
<p>Sidewalks are deficient and crosswalks not existing</p>

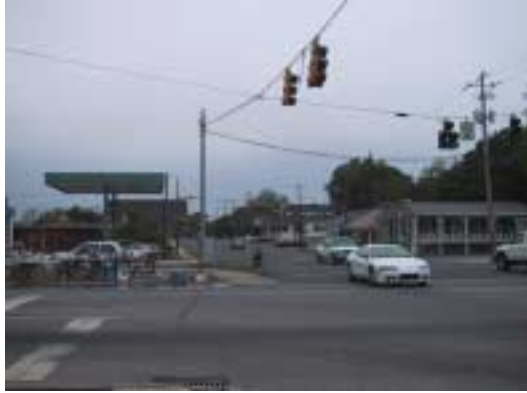
Intersection	Observation 1	Observation 2
<p>East Avenue and Main Street <i>(Signalized intersection)</i></p>	  <p>Lanes shift, deficient lane markings, numerous driveways near intersection</p>

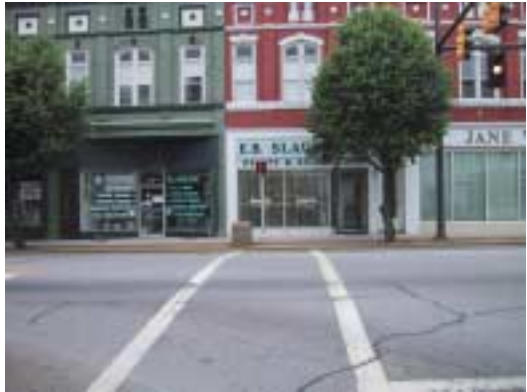
<p>Sidewalk ramp needed for physically challenged</p>

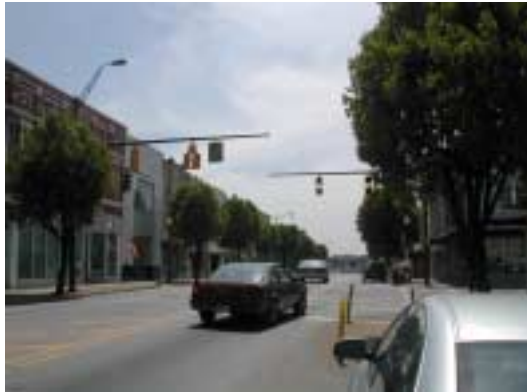
<p>Plastic poles should be replaced with landscaped bulb-outs</p>

Intersection	Observed Deficiencies	Recommended Improvement	Estimated Cost	Priority Rank
West Avenue and Main Street <i>(Signalized intersection)</i>	Plastic poles at intersection are not effective, or aesthetically pleasing in a downtown environment	Replace with landscaped bulb-outs	\$3,000 Each	3
	Sidewalk ramp needed at crosswalk along eastern side of Main Street	Add ramp to existing sidewalk	\$700 Each	1
Canal Street and Main Street <i>(Signalized intersection)</i>	Poor signage to prohibit trucks in downtown area (trucks are warned too late, and without acceptable places to turn around)	“Truck prohibited” signs need to be installed at the eastbound, westbound and northbound approaches to this intersections to avoid trucks from traveling within downtown on Main Street. The signs need to be at least 30-inches in size and placed on the signal mast arms and ALSO at mid-block before the intersection (to allow adequate warning).	\$7,500	2

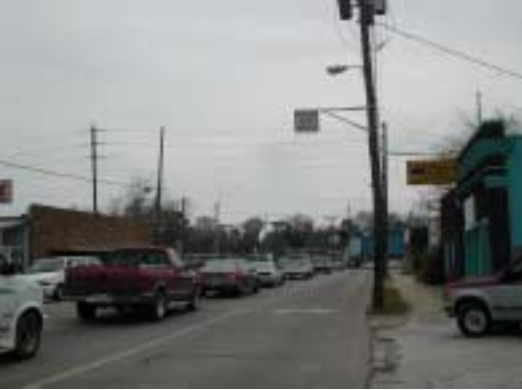
Intersection	Observation 1	Observation 2
<p>Canal Street and Main Street <i>(Signalized intersection)</i></p>	  <p>Better signage needed to prohibit large trucks downtown</p>

Existing “No Trucks” sign on Main Street is too small	Replace with a 30-inch sign.	\$200	2
College Street, Wissahickon Avenue, and East Avenue <i>(Signalized intersection)</i>	East Ave and Wissahickon Avenue are not aligned (through lanes shifts).	One potential option would be to straighten the curve; this would require taking much of the front yard of the Gammage Funeral Home on the northeast corner of this intersection. The resulting curve would still be difficult to navigate.	\$45,000	3
	Two-way-left-turn lane on College Street (south of intersection with East Ave)	Re-mark as a left turn bay only (currently marked as a center two-way left-turn lane).	\$2,250	1
	No pedestrian crosswalks or signalization	Add crosswalks and pedestrian signals across College Street, Wissahickon, and East Avenue	\$15,000	2
North/South Philpot Streets and East Avenue <i>(Signalized intersection)</i>	Left-turn signalization at this intersection does not appear to be warranted based upon review of available data.	GDOT needs to assess timing for left-turn protective phases, and possibility of eliminating phase if not required.	\$3,000	2

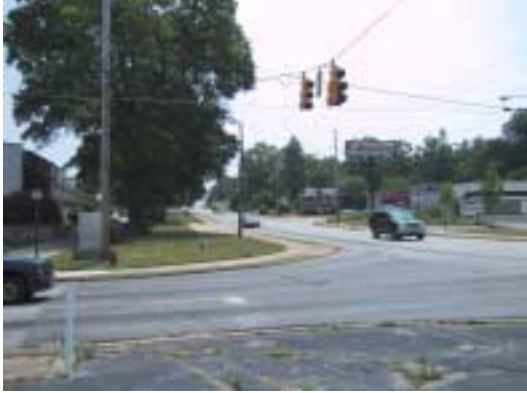
<p>Right-turn lane recommended from WB East Ave. to NB Philpot Street</p>

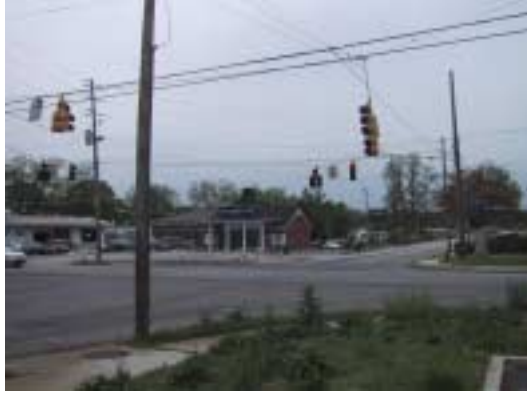
<p>Timing for left turn protective phasing seems excessive</p>
<p>College Street and West Avenue <i>(Signalized intersection)</i></p>

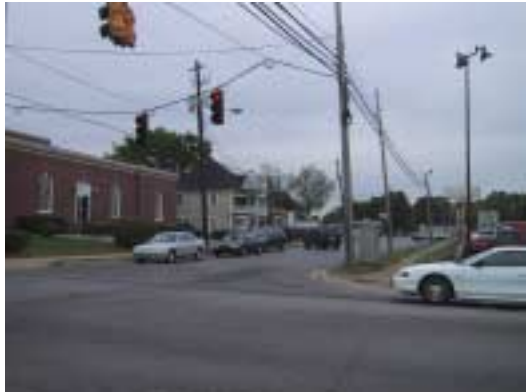
<p>US Post Office parking lot causing traffic congestion</p>

Intersection	Observed Deficiencies	Recommended Improvement	Estimated Cost	Priority Rank
College Street and West Avenue <i>(Signalized intersection)</i>	Congestion and queues at the US Post Office driveway on College Street, cause congestion and queuing at this intersection	1) Close off existing parking facility at Post Office 2) Restripe College Avenue (south of West Ave), with the following configuration: two 14-foot lanes, and one 8-foot parallel parking strip. This configuration will allow for the same number of parking spaces as currently exists in the lot.	\$15,000	2
	No Crosswalks/Pedestrian Signalization/ADA ramps	Add ramps and ped cross-walks	\$11,000	2
George West Road / Wiley Drive / John Phillips Road / Blanche Avenue and Main Street <i>(Unsignalized intersection)</i>	This intersection has several geometric deficiencies	Intersection is being redesigned as part of the North Main Street Project. May need a signal in the long-term future (by 2022), assuming current growth trends continue.	N/A	N/A

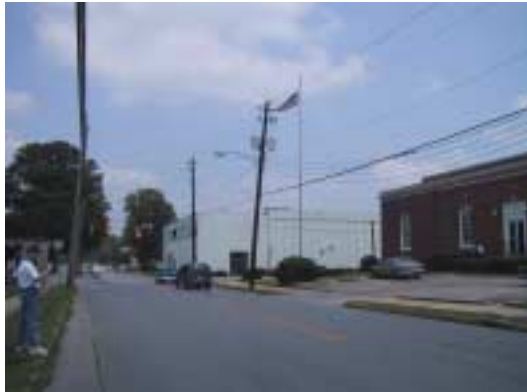
<p>Close lot, replace with on street parking on College St.</p>

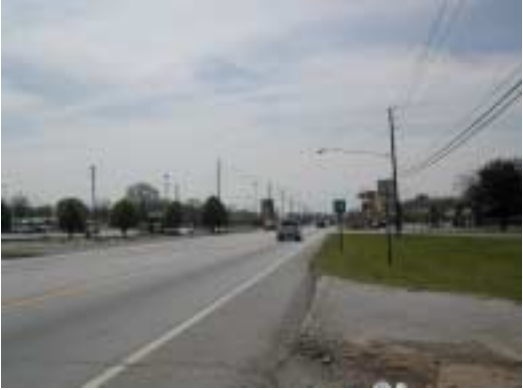
<p>Blanche Ave. intersection to be reconstructed by GDOT</p>

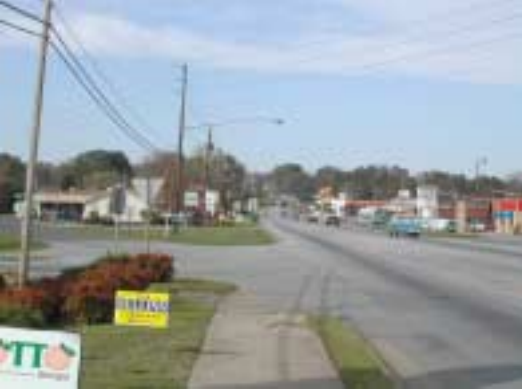
<p>GDOT constructing cul-de-sac at John Phillips Road</p>
<p>Jule Peek Avenue and College Street <i>(Unsignalized intersection)</i></p>

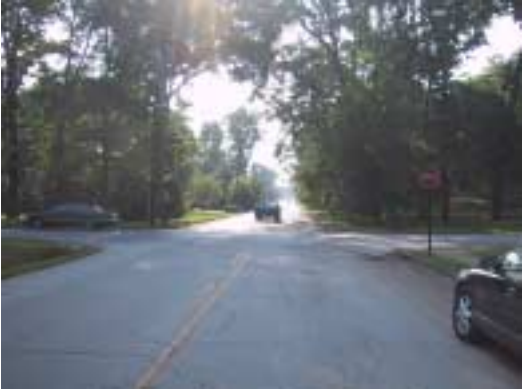
<p>Stop sign on Jule Peek too small and difficult to see</p>

Jule Peek Avenue and College Street <i>(Unsignalized intersection)</i>	Stop signs are too small	Replace 24-inch sign with 30-inch or 36-inch signs.	\$400	1
	There is a slight lane shift on Jule Peek	Restripe center line on East Jule Peek	\$2,300	2
	Passing line (dashed center line) is not warranted on West Jule Peek	Restripe with SOLID yellow line.	\$300	2
Girard Avenue and College Street <i>(Unsignalized intersection)</i>	Stop signs are too small	Replace 24-inch sign with 30-inch or 36-inch signs.	\$400	1
	Stop sign on West Girard is difficult to see	Consider moving sign to utility pole (pole obstructs view of sign from a distance).	\$200	2
	Dip in road (Girard crossing College) causes vehicles to slow so they do not scrape bottom of their vehicles.	Reconstruct draining along this intersection to allow a more gradual crown and better/safer vehicular movement.	\$15,000	2
	High number of angle-type collisions at this intersection	To increase driver awareness of this intersection, add sign stating "Cross Traffic Does Not Stop" per MUTCD specifications.	\$400	1

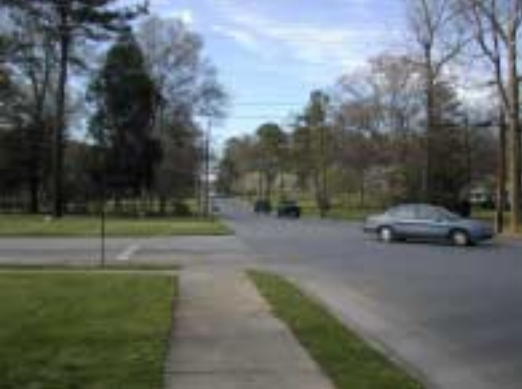
<p>Advise Jule Peek drivers that cross-traffic does not stop</p>

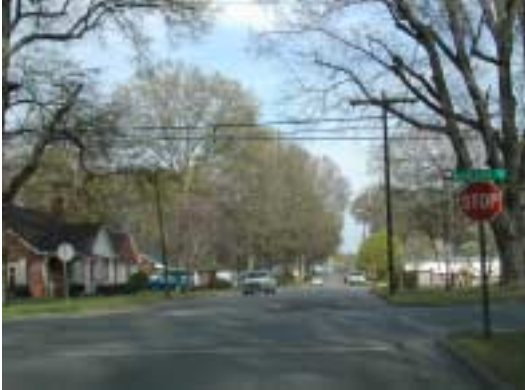
<p>Road dip across College Street slows vehicle crossings</p>

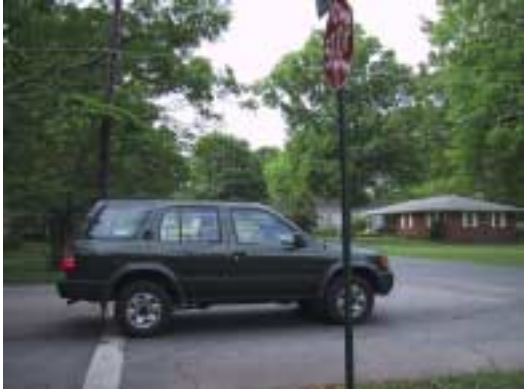
<p>Stop line too far back to see oncoming traffic</p>

Intersection	Observed Deficiencies	Recommended Improvement	Estimated Cost	Priority Rank
Cave Spring Road and Girard Avenue <i>(Unsignalized intersection)</i>	Stop signs are too small, and are not angled towards drivers	Replace 24-inch sign with 30-inch or 36-inch signs, and make sure they are angled perpendicular from to the roadway.	\$400	1
	Horizontal sight distance problem on westbound Girard Avenue at intersection (bushes and trees looking southbound on Cave Spring Road obstruct view of oncoming traffic (which does not have to stop)).	Tree trunks appear to be off of the right-of-way; however, brush hanging over road right-of-way should be trimmed where feasible.	\$2,000	1
	Speeding vehicles on Cave Spring Road were also observed.	1) Increase enforcement of speed limit 2) Determine if intersection requires warrant four-way stop control	\$5,000 Engineering Study	2
	Centerline on Girard Ave is very wide (16 feet) which may be causing excessive speeds.	Construct four-foot wide bike lane on either side to reduce lane widths on Girard Avenue to 11 feet. This would also improve pedestrian connectivity through Cedartown. However, with excessive asphalt drop-off near curb (from past re-paving layering), this may warrant the need for asphalt "smoothing" to reduce the likelihood of bicycle incidents.	\$25,000	3

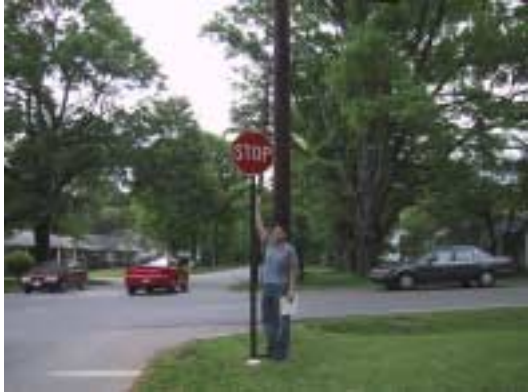
<p>1) Stop sign too small, 2) advise Girard traffic that cross-traffic does not stop</p>

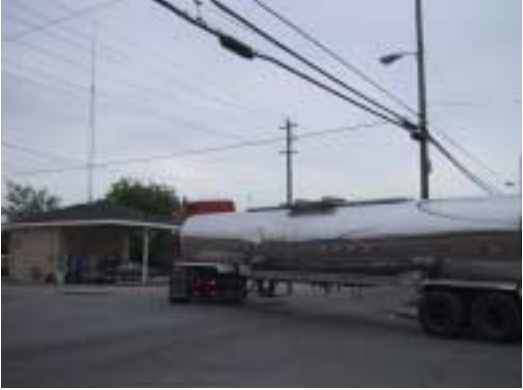
<p>Curb radius too small for large trucks</p>

North Furnace Street and West Avenue <i>(Unsignalized intersection)</i>	Curb radii not large enough to accommodate truck traffic using intersection (turning between Furnace Street and West Avenue). Trucks observed to need two-way left-turn lane on West Ave. to maneuver turns	Redesign intersection to provide larger turning radius (50 to 100-feet) to allow trucks traveling westbound onto West Avenue from Furnace Street. This will require the relocation of at least one utility pole, and obtaining right-of-way from <i>Alejandras Super Market</i> property.	\$35,000	3
	Stop sign on Furnace Street too low	Bottom of stop sign needs to be at least 7 feet above ground surface (per MUTCD).	\$200	1
	No stop line on either side of Furnace Street	Paint stop lines on both sides of Furnace Street – lines need to be at least 24 inches wide	\$500	1
	No center line markings on Furnace Street	Paint center line on Furnace Street	\$500	2

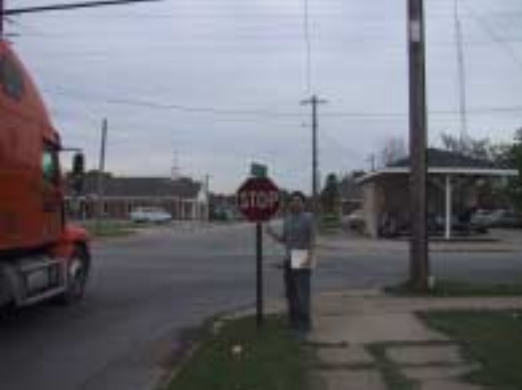
<p>Stop sign too low, No stop line or center line</p>
<p>South College Street and Canal Street <i>(Unsignalized intersection)</i></p>

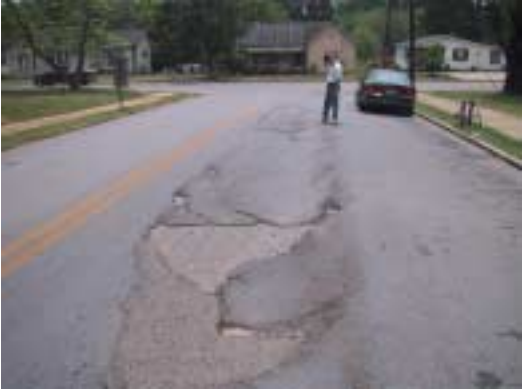
<p>Asphalt needs replacement</p>

Intersection	Observed Deficiencies	Recommended Improvement	Estimated Cost	Priority Rank
South College Street and Canal Street <i>(Unsignalized intersection)</i>	Asphalt condition poor on downhill slope approaching West Avenue.	Replace asphalt in select locations to bring up to satisfactory condition.	\$10,000	2
	Standing water observed at bottom of hill (intersection of College Street at West Avenue). No drain observed in this location. Additionally, the dip at this location requires a slow approach by vehicles entering intersection (so they do not scrape the bottom of their vehicles).	To eliminate standing water and provide a "smoother" approach for vehicles, add asphalt patch at bottom of hill.	\$10,000	2
	Future Traffic Operational Issues (by Year 2022)	May need a signal in the long-term future (by 2022), assuming current growth trends continue.	N/A	N/A
Ware Street and Main Street <i>(Unsignalized intersection)</i>	Curb radii not sufficient to handle truck traffic (truck observed having to use two-way left turn lane on Main Street to maneuver turn).	Better enforce truck traffic downtown. Encourage eastbound trucks on Ware Street turning north onto Main Street to use Philpot Street (through better signage).	N/A	N/A

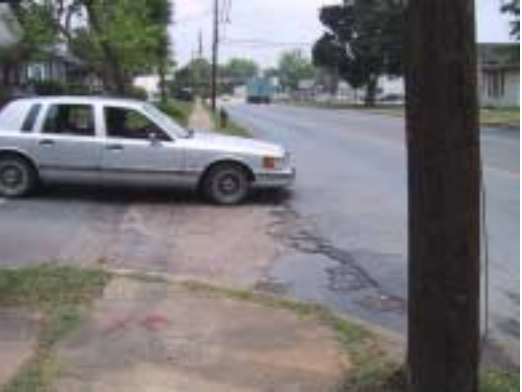
<p>Dip in road slows vehicles entering intersection, and causes ponding of water (no drain)</p>

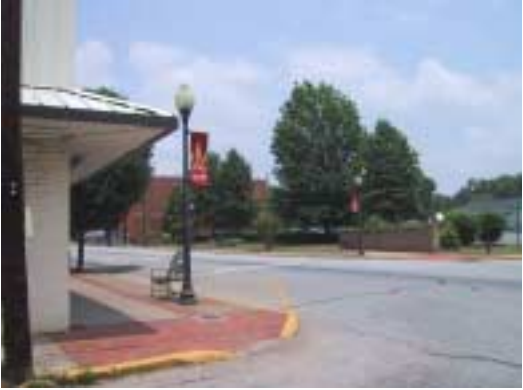
<p>Difficult to see oncoming traffic</p>

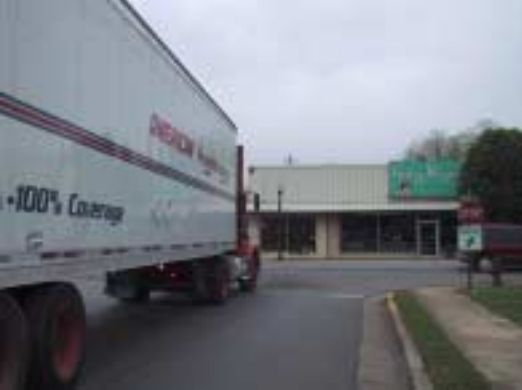
<p>Ware Street not designed for large trucks</p>
<p>Highland Avenue/Greenwood Drive and East Avenue <i>(Unsignalized intersection)</i></p>

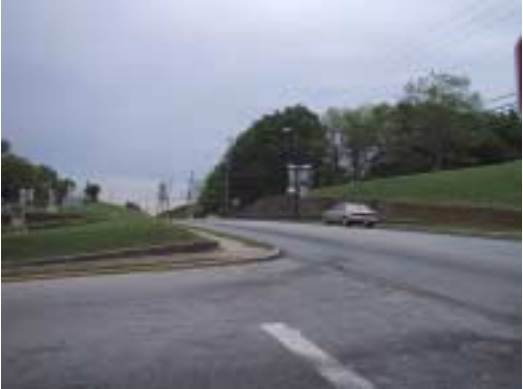
<p>Crest of hill reduces vertical sight distance</p>

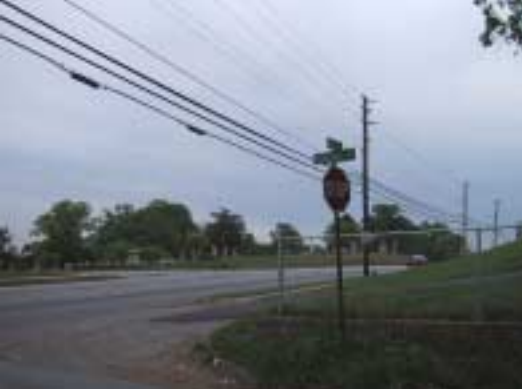
<p>Crossing From Highland to Greenwood difficult</p>

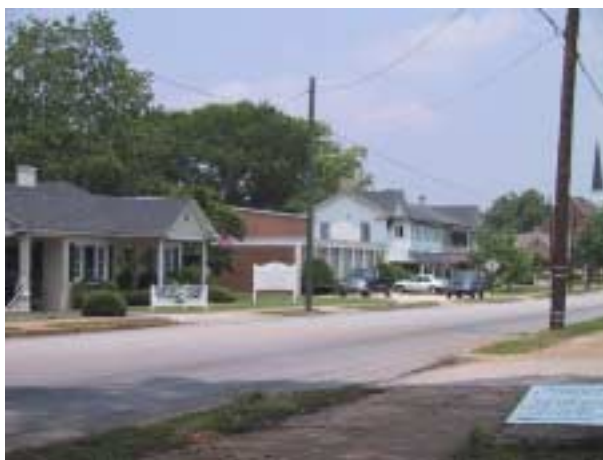
Another marking noted that is not consistent with the Manual of Uniform Traffic Control Devices (MUTCD) is the use of yellow paint for pedestrian crosswalks; the MUTCD requires the use of white paint for such markings. Using yellow paint for pedestrian crosswalks goes against the MUTCD, is not consistent with other crosswalks, is difficult for drivers to see, causes confusion to drivers; thus, is not safe for pedestrians.

Yellow Painted Crosswalk - College Street (north of Sterling Holloway Pl.)

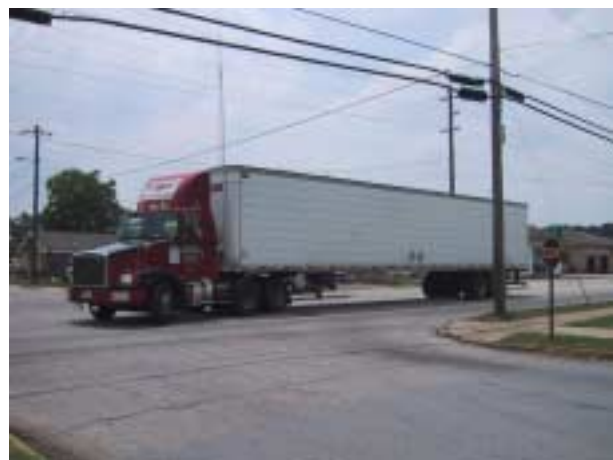
Throughout the study area, it was evident that there are numerous locations that have inadequate or deficient lane markings. Specifically, the lane markings are either faded, have been paved over and not replaced, or just not existing. This is especially dangerous in situations where lanes shift (e.g. East Avenue and Main Street).

Faded Stop Line and Center Line Marking at Furnace Street and West Avenue

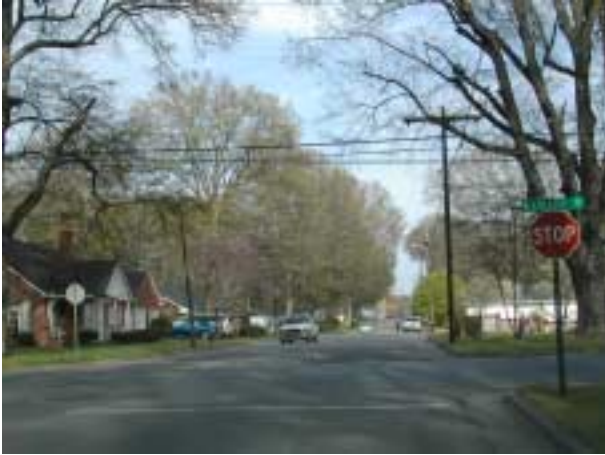
One final observation noted is that many streets have excessive lane widths (e.g. Girard Avenue with 16-foot lanes). These wide lanes may be encouraging higher speeds of travel. In addition to better enforcement of

Wide Street Lanes – Girard Avenue Near North College Street

the speed limits, one potential option would be to re-stripe select roads to allow for the addition of four foot bike lanes in each direction. This would improve pedestrian connectivity throughout Cedartown and allow for better use of the existing asphalt roadways. Should bike lanes not be a favored option, restriping to allow for one-side on-street parking would also be feasible.

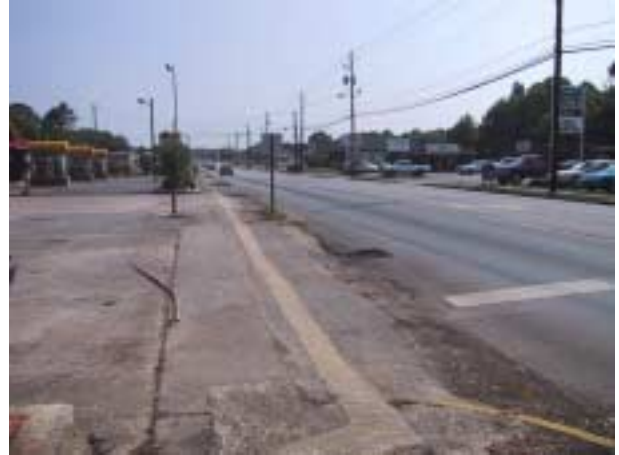
Another item that was observed, especially along the North Main Street corridor is the excessive number of driveways near many intersections. For example, many businesses have more than one entrance/exit along Main Street, most of which do not appear to be needed. As discussed in **Section 2.2, Accident Analyses**, high numbers of rear-end collisions may be attributed to the unusual number of driveways allowing access to and egress from the street near the intersection. Unexpected movements in and out of these driveways could cause mainline vehicles to stop suddenly.

Excessive Number of Driveways – North Main Street at East Girard Avenue

Better access management techniques (e.g. reducing the number of needed driveways or restricting left turn maneuvers from select driveways onto Main Street) would likely help to reduce the high number of rear-end collisions along this corridor.

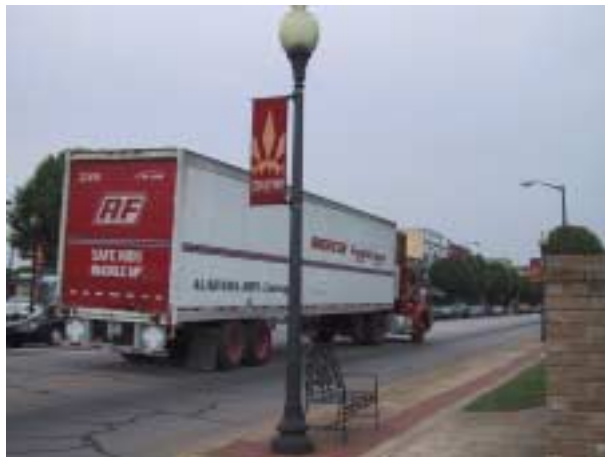
Truck traveling north on Main Street into Downtown

throughout the City. It was noted during the site visits to Cedartown that many trucks travel on roads where they are prohibited. Better advance signage (e.g. on the approaches to the intersection of Canal Street/MLK and Main Street) would likely reduce the number of such occurrences.

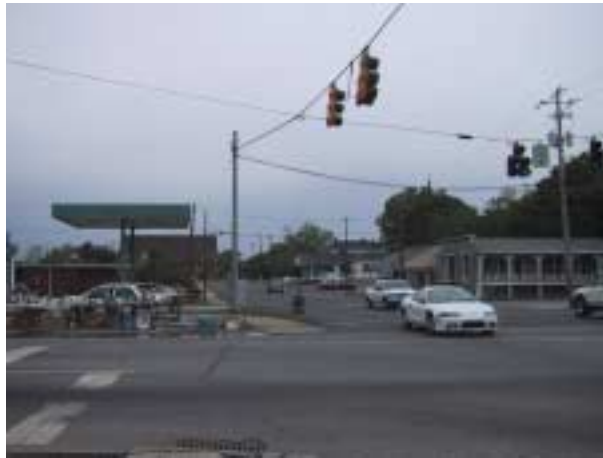
The state of the sidewalks throughout Cedartown are mixed. Certain areas have sidewalks, but many are in poor condition, or do not connect to needed pedestrian locations. As noted in the Master Plan, sidewalk improvements are recommended throughout the City. These improvements will not only provide a safer environment for pedestrians, but will ultimately improve vehicular operations and safety, as well.

Physically Challenged Citizen Choosing Road over Sidewalk Along East Avenue
